Baldock Town Hall

During May 2011 Stanburys Ltd offered their services to BTHG to complete a condition survey on Baldock Town Hall and produce a report on their findings. Permission was sought from NHDC for access to the Town Hall, which was granted. Stanburys completed the survey over the course of a couple of days, completing a fully documented report of their findings. An outline copy of the report was submitted to NHDC for their records. The survey was carried out at no cost to BTHG.

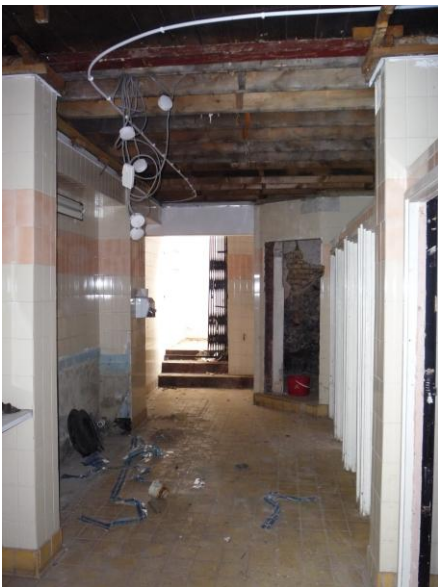
- The floorboards were damaged in some areas of the main floor.
- The rooms are in poor decorative order.
