Confirmation of Tree Preservation Order TPO/00208 (2023) – 1x Common Beech (*Fagus sylvatica*), 4 Coach Drive, Hitchin, Herts.

DETAILED TREE INSPECTION

Common beech (*Fagus sylvatica*)

4 Coach Drive

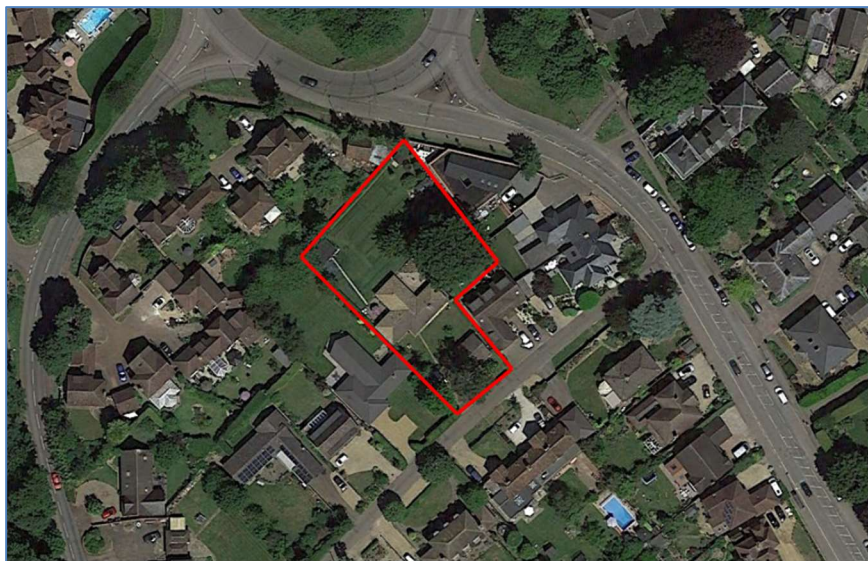
Figure 1 – Aerial view of the common beech within the garden of 4 Coach Drive (Google Earth 2023)

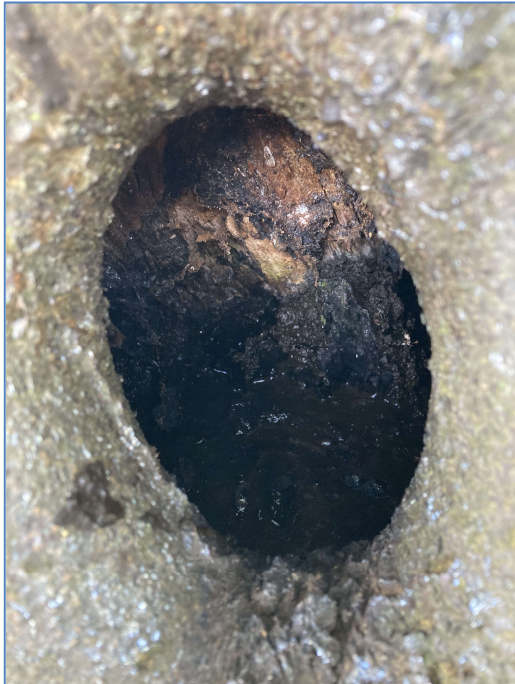
A cavity was noted on the eastern stem at approximately 3m above ground level (*see figure 2*). Measurements were taken at this point where the cavity was found to be 70mm wide, 110mm in height, 190mm deep (horizontal measurement) and 400mm deep (vertical measurement). The internal survey of the cavity found it to be anaerobic with exposed heartwood, although no signs of internal decay were noted. The area surrounding the cavity was also struck with a sounding hammer, where no significant change in resonance was found.

This cavity has been dismissed as being of any negative structural significance given the dimensions of the cavity, anaerobic conditions, lack of decay and fungal fruiting bodies, along with the overall diameter of the stem (780mm) where the cavity is located.

Figure 2 – Cavity on eastern stem at 3m

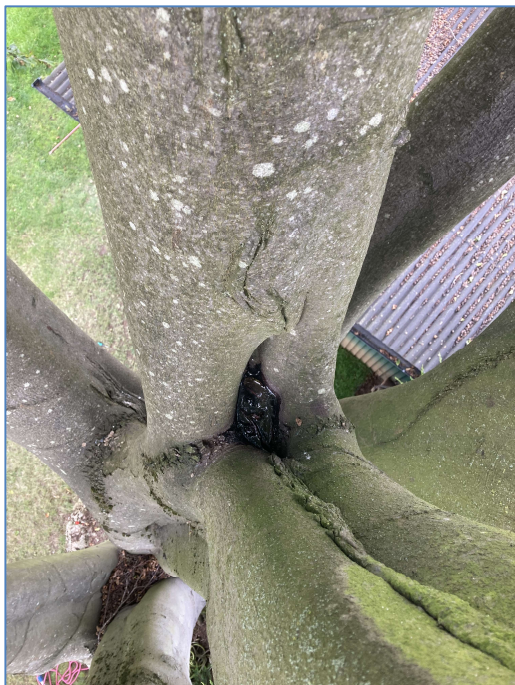
A small water pocket (*see figure 4*) was also identified within an indentation between a branch union at approximately 5m above ground level on the northeast side of the crown.

Figure 4 – Water pocket in union indentation

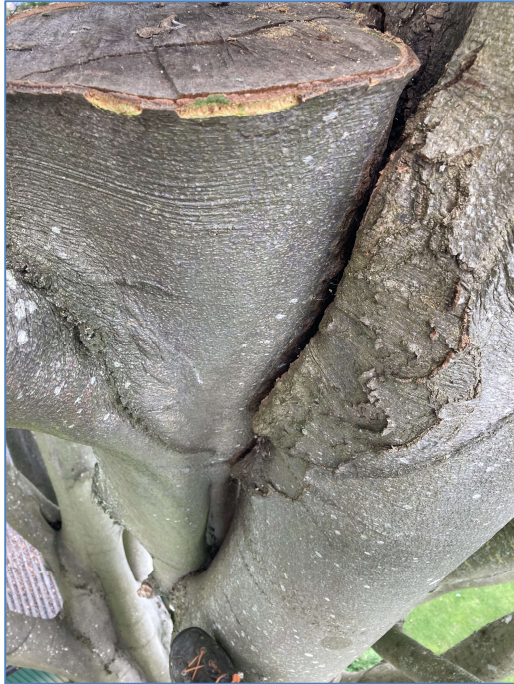
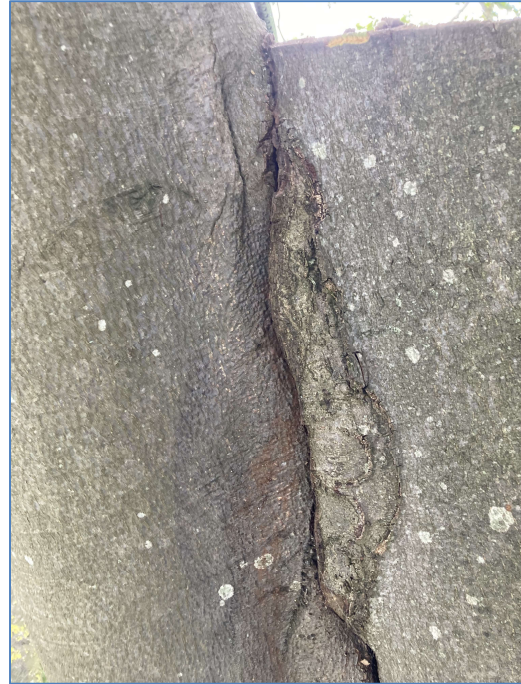
The overall crown form was found to be typical of the species given its open growing conditions, however there has been a reduction in the overall crown mass due to the recent removal of a large branch. The limb was removed due to the fusion of two large branches has left a hole within the crown on the west side of the canopy.

Figure 6 & 7 – Wounding from stem removal and reaction wood from crossing and rubbing stems

It is recommended that a crown reduction of 2m (height and radial spread) is initially conducted **within 6 months** of this report. The tree should then be left for two growing seasons, allowing to recover from the shock of pruning and put on some new growth.

After this period has elapsed, a visual inspection of the tree's vitality should be conducted by a qualified Arboricultural Consultant to assess its physiological condition and determine if the tree is healthy enough for the second stage crown reduction. The crown should be reduced a further 2m (height and radial spread), further decreasing the sail effect of the canopy.
