DETAILED TREE INSPECTION

Common beech (*Fagus sylvatica*)

4 Coach Drive

MH8963

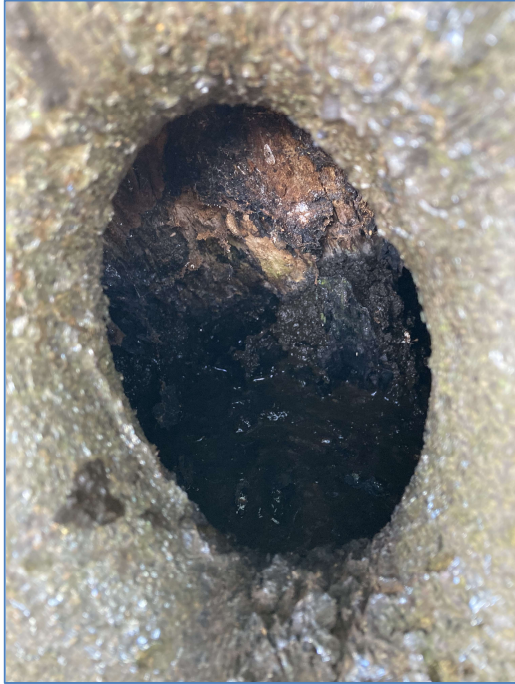
A cavity was noted on the eastern stem at approximately 3m above ground level (*see figure 2*). Measurements were taken at this point where the cavity was found to be 70mm wide, 110mm in height, 190mm deep (horizontal measurement) and 400mm deep (vertical measurement). The internal survey of the cavity found it to be anaerobic with exposed heartwood, although no signs of internal decay were noted. The area surrounding the cavity was also struck with a sounding hammer, where no significant change in resonance was found.

This cavity has been dismissed as being of any negative structural significance given the dimensions of the cavity, anaerobic conditions, lack of decay and fungal fruiting bodies, along with the overall diameter of the stem (780mm) where the cavity is located.

Figure 2 – Cavity on eastern stem at 3m

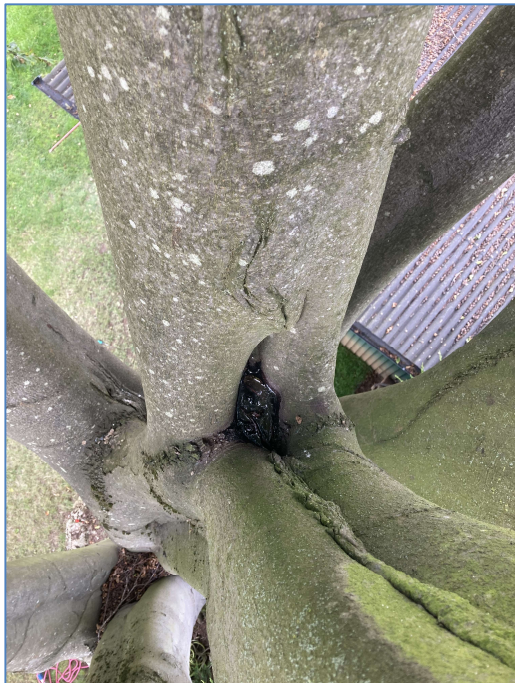
A small water pocket (*see figure 4*) was also identified within an indentation between a branch union at approximately 5m above ground level on the northeast side of the crown.

Figure 4 – Water pocket in union indentation

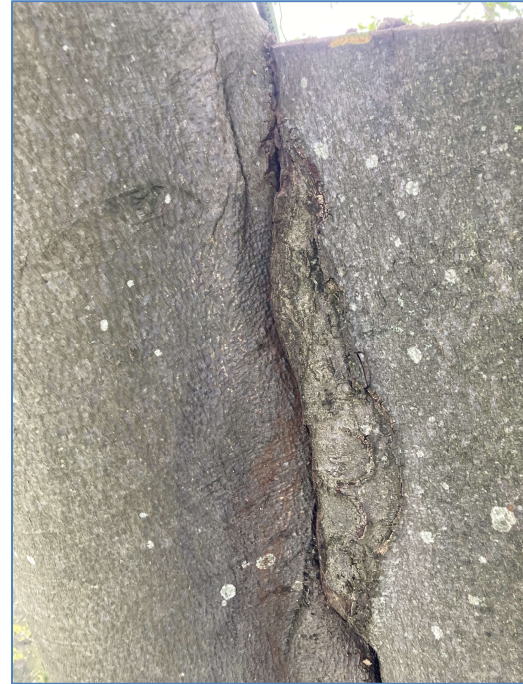
The overall crown form was found to be typical of the species given its open growing conditions, however there has been a reduction in the overall crown mass due to the recent removal of a large branch. The limb was removed due to the fusion of two large branches has left a hole within the crown on the west side of the canopy.

Figure 6 & 7 – Wounding from stem removal and reaction wood from crossing and rubbing stems
