BUTTS CLOSE GREENSPACE ACTION PLAN (GAP) 2016 – 2021

January 2016

The GAP for Butts Close sets out the management, maintenance and development framework of the site over five years.

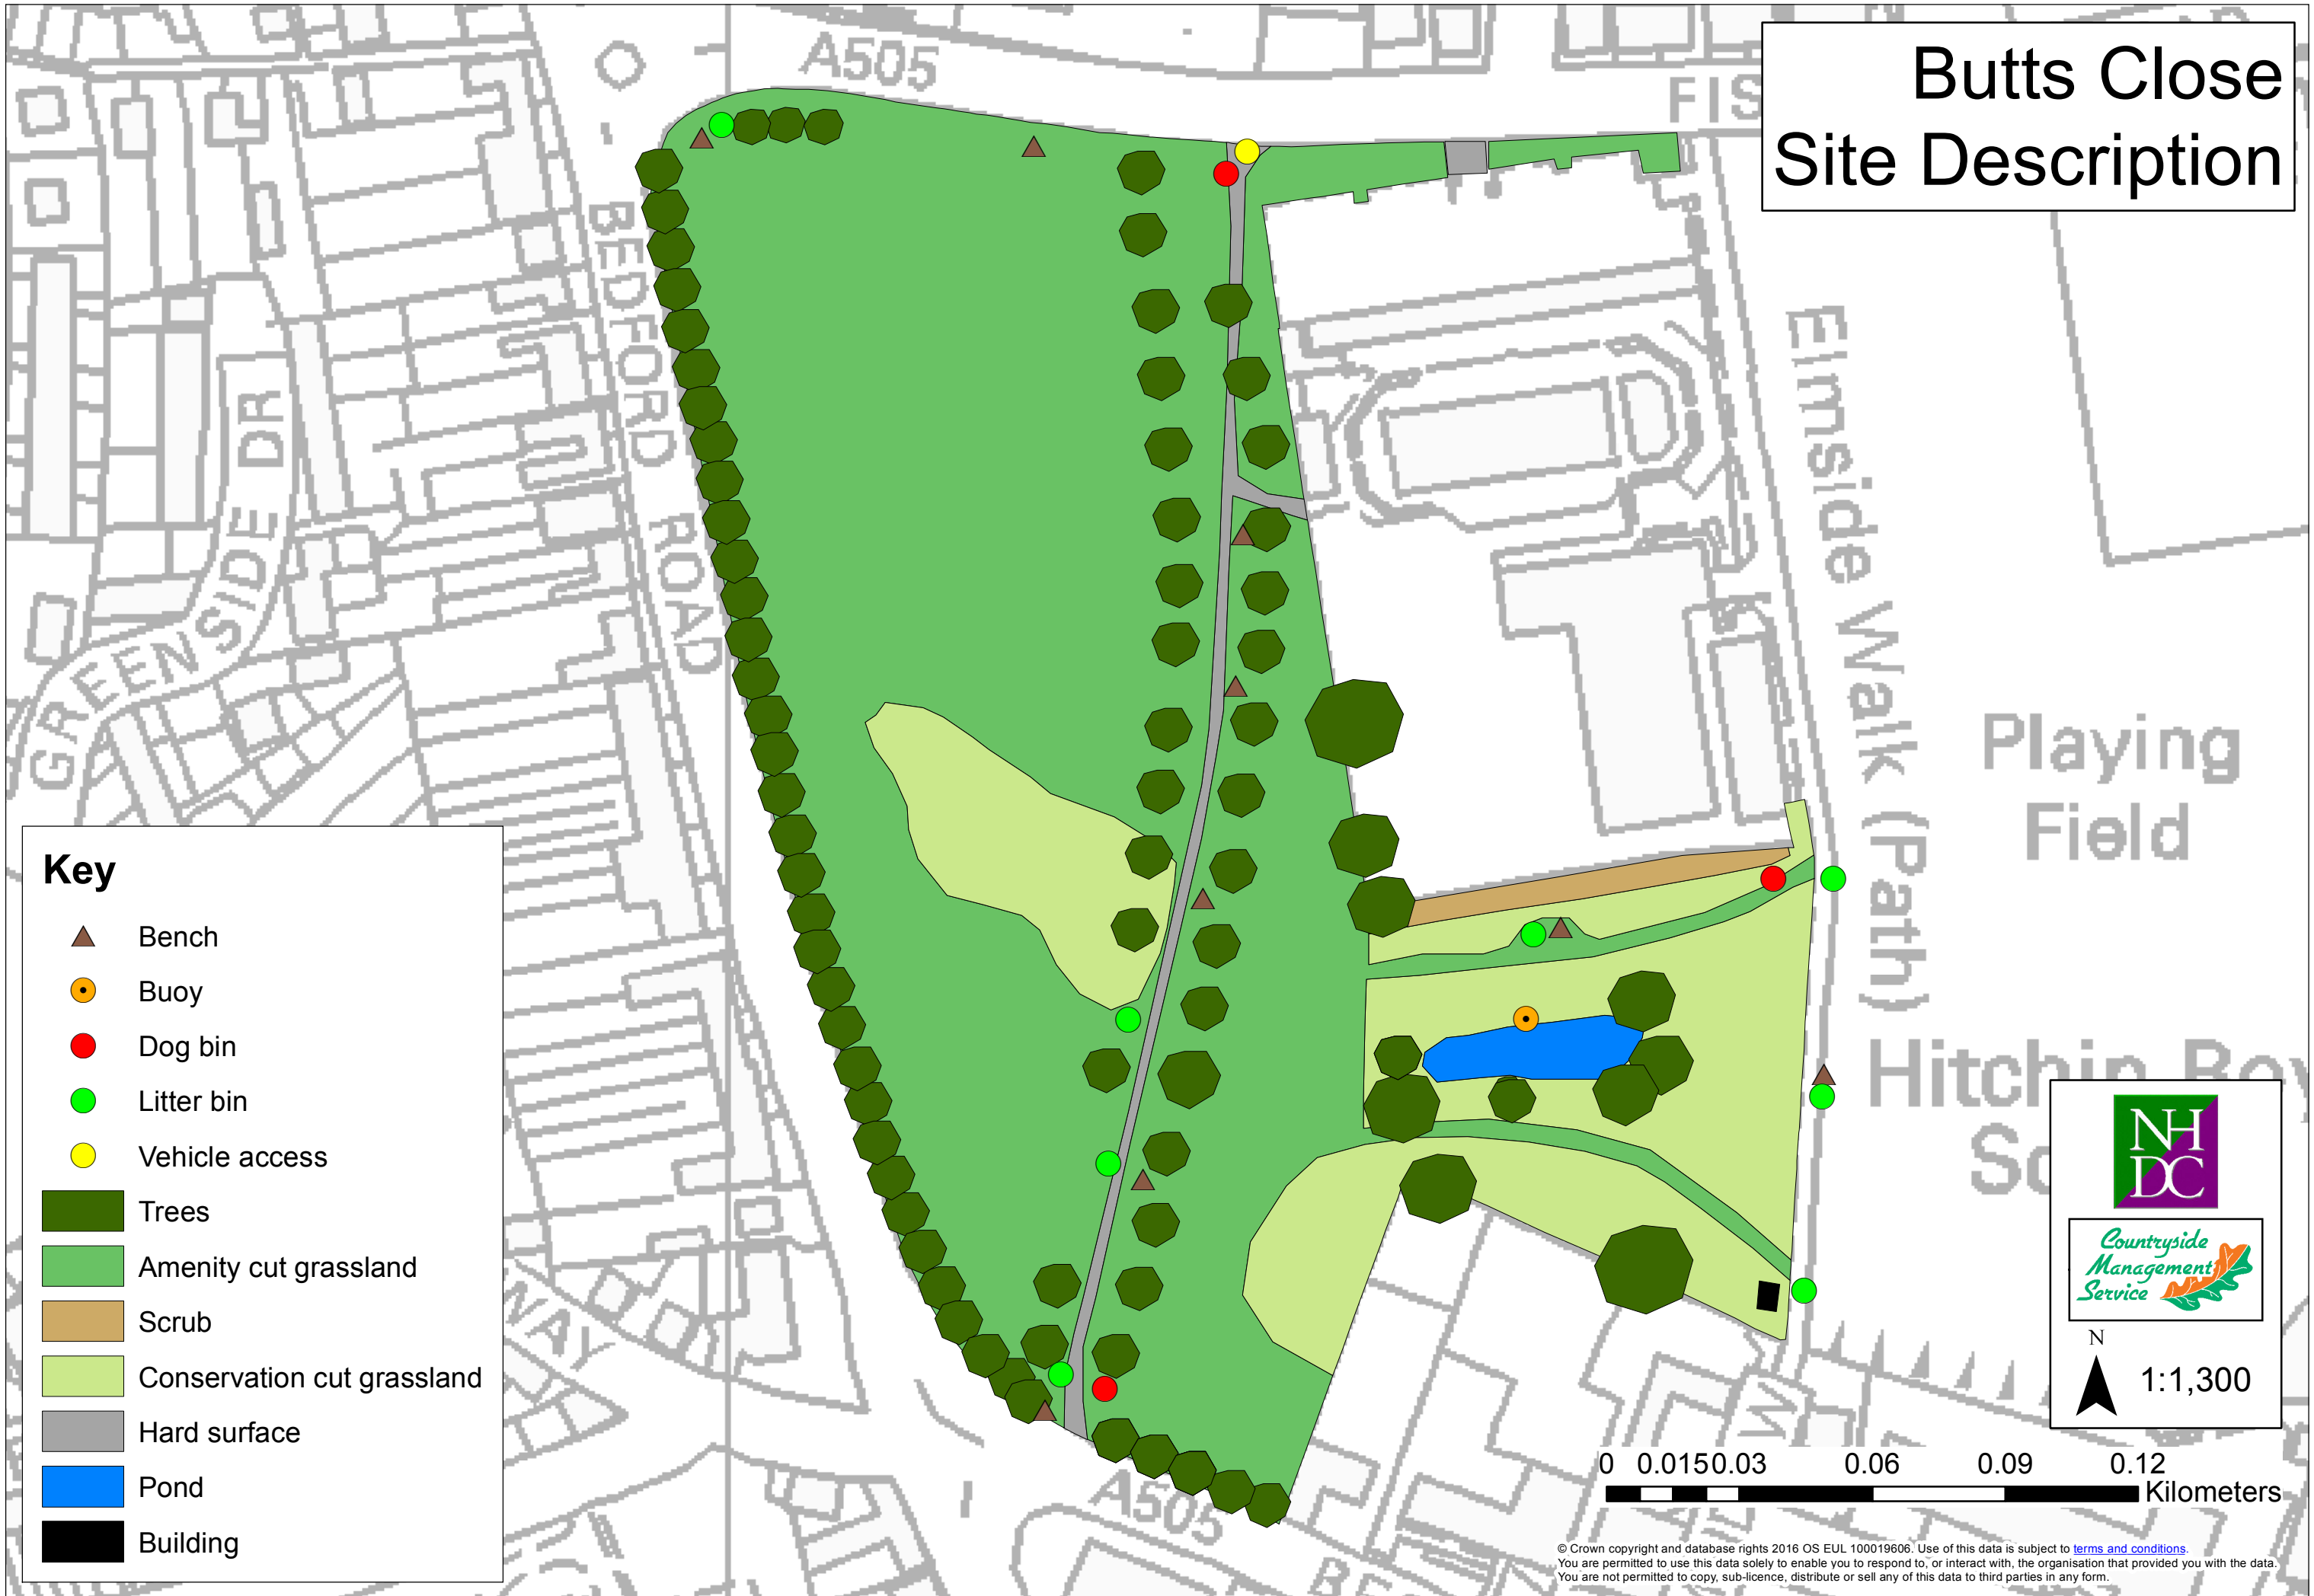
Butts Close Site Description

- Bench
- Buoy
- Dog bin
- Litter bin
- Vehicle access
- Trees
- Amenity cut grassland
- Scrub
- Conservation cut grassland
- Hard surface
- Pond
- Building

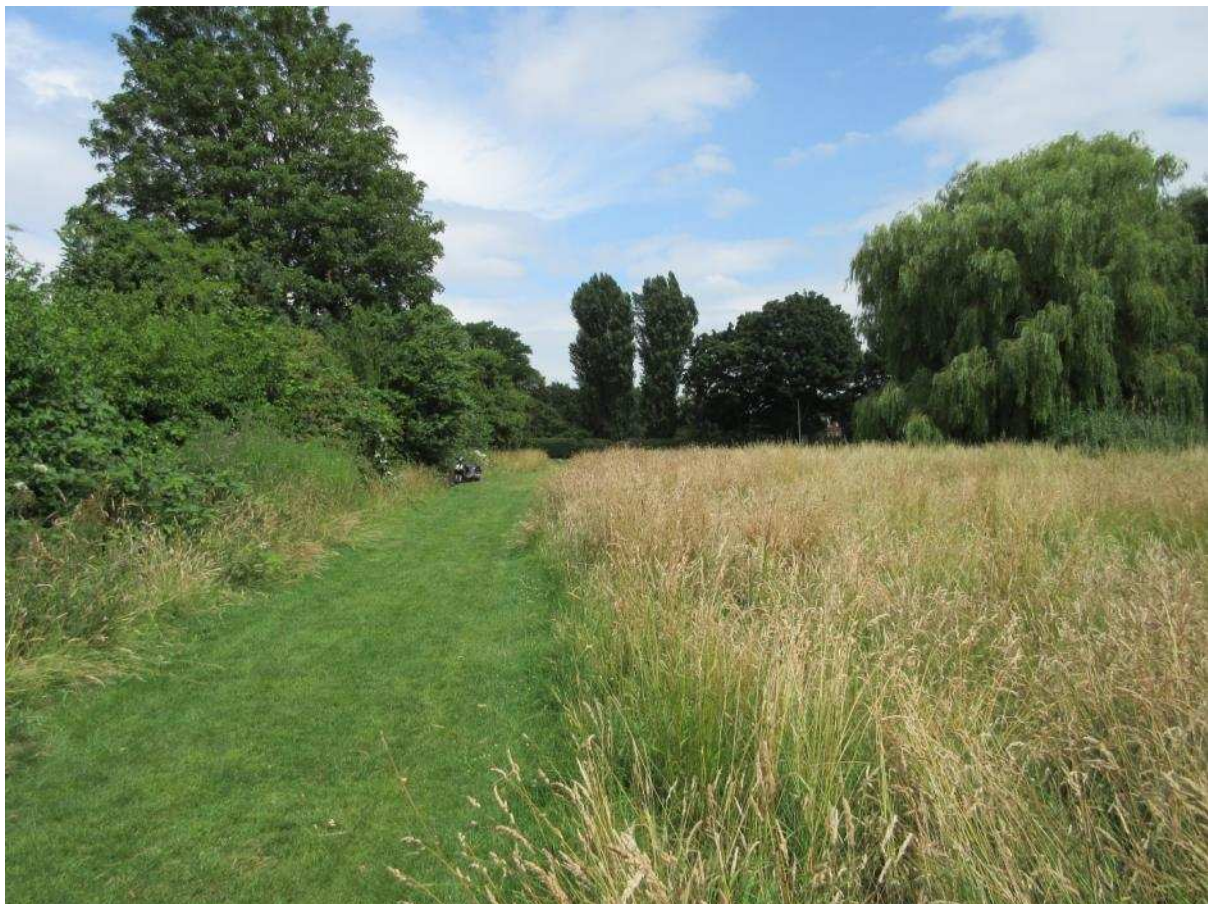
Conservation cut grassland and scrub north of the pond

The shrubs planted north of the pond in 2007 have established very successfully. They are now approaching maturity and should be coppiced to encourage dense future growth. Whilst carrying out this work, an old fence line running along this boundary can now be removed, as it no longer serves any purpose.

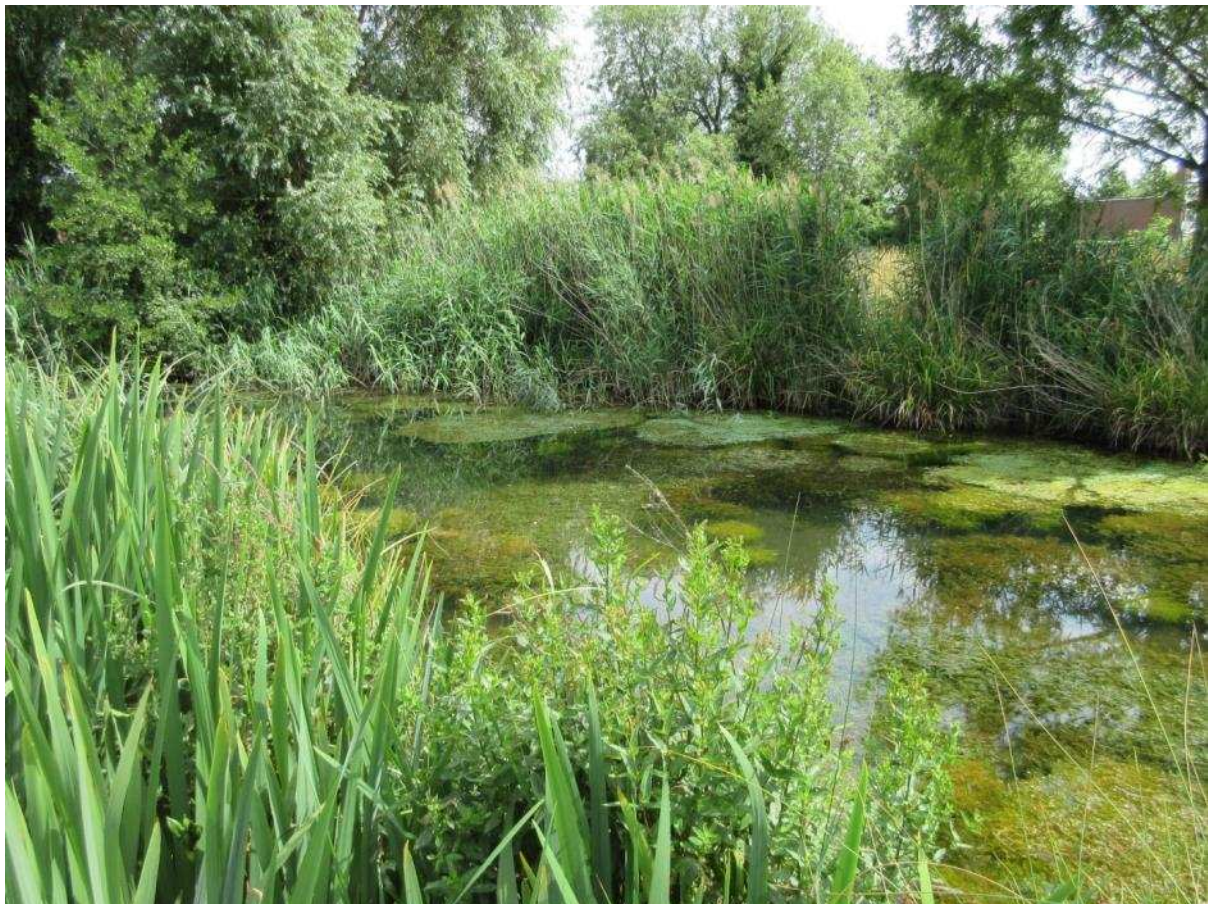
The main part of the pond

These works achieved significant improvements to the habitats in and around the main western section of the pond, which have matured well in the eight years since. The water in the pond is clear and free of algal blooms and the pond is surrounded by thick emergent

There has been a significant accumulation of silt in the base of both parts of the pond since the previous works were carried out. This has reduced the capacity of the pond and will therefore reduce its effectiveness as a balancing pond.

As noted in 2.8.3, the quantity of silt in the base of the pond has increased significantly since 2007. This affects the main function of the pond as a balancing pond by reducing its capacity. Works to desilt the pond should be designed and costed at the beginning of this GAP, and funding sought to carry them out. A decision on desilting should precede any other works carried out on or around the pond.

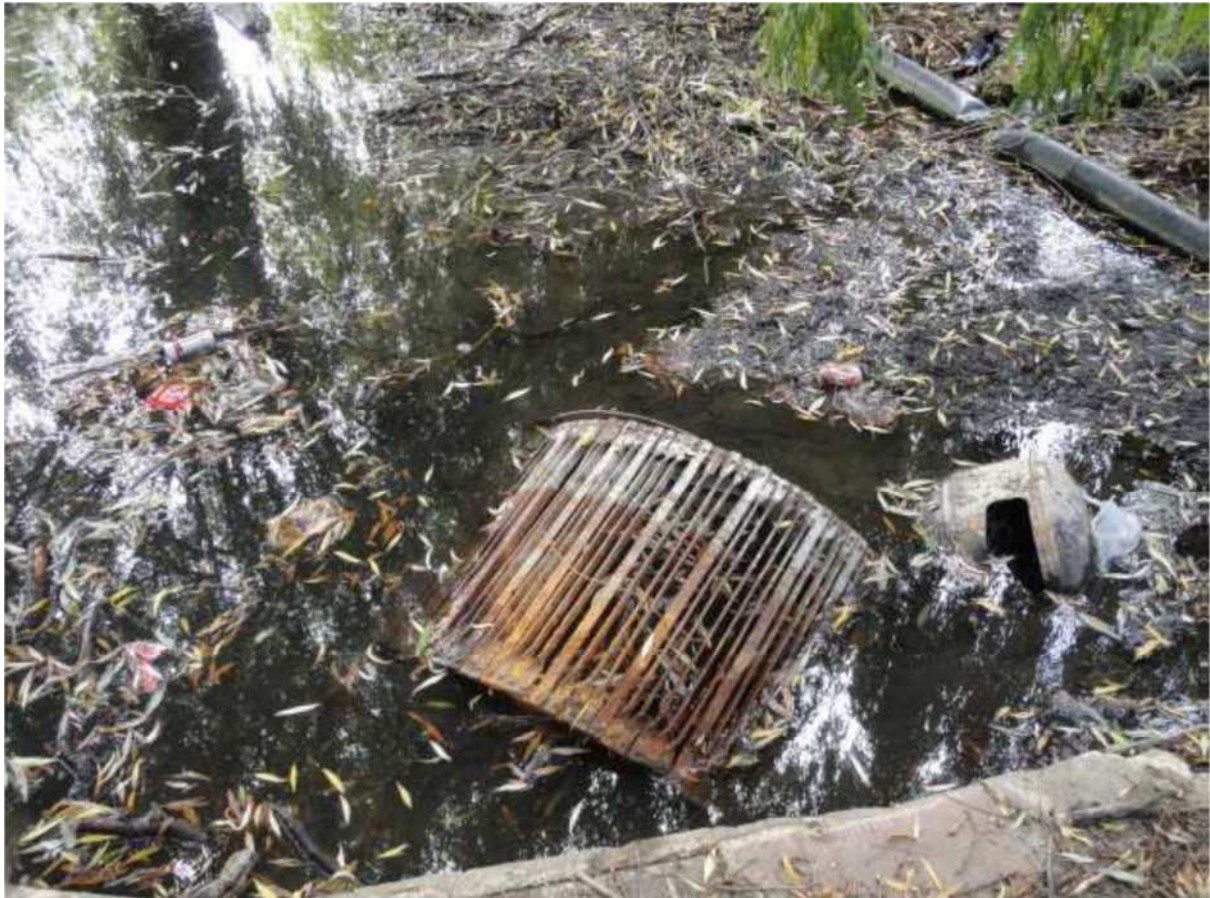
vegetation. The trees have grown back strongly, to the extent that the eastern end of the pond had once again become heavily shaded by the large weeping willow until that recently lost several large branches. This part of the pond remains far less attractive, being dominated by silt, algae, leaf litter and debris.

The eastern end of the pond, showing the structure which supported the floating reedbed in the top right corner

The tall marginal vegetation which the grounds maintenance contractors are unable to access should be cleared during the autumn every 2-3 years to reduce the build-up of biomass. The crown of the large weeping willow should be reduced and the two sallows pollarded once again, to bring more light to the pond and to reduce the amount of leaf litter falling into the water.

This will open up the eastern end of the pond, allowing a floating reedbed to be re-established on the existing framework. This will perform the valuable function of filtering nutrients and pollution from the water in this part of the pond, and considerably improve its appearance. In order for the reedbed to persist, the growth of the weeping willow will need to be monitored. When it has grown back sufficiently to shade this area completely its crown should be reduced again.

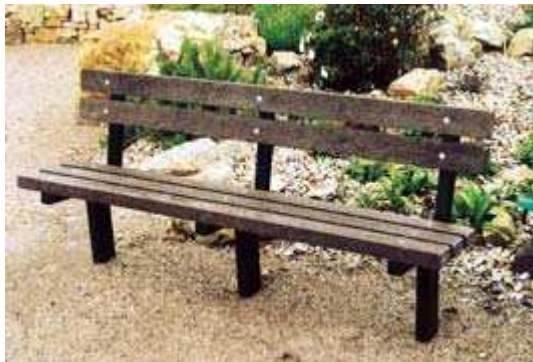
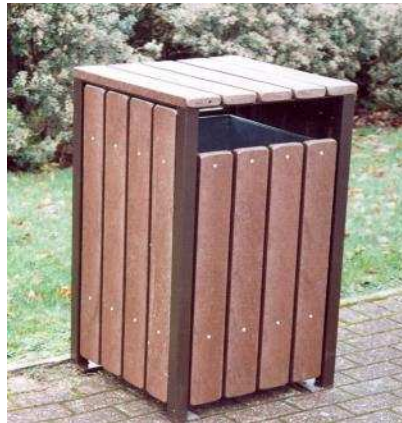
Examples of bench and bin design (www.streetmaster.co.uk)

The litter bins at Butts Close are of an open-topped design which allows litter to be easily spread around, particularly when they are full. In addition, it may be more logical for bins to be sited next to benches. These bins should be replaced and re-sited.

The benches on site remain functional but are ageing. The replacement of bins and the development of signage and interpretation provide an opportunity for these benches to be upgraded to achieve a consistent style across all site furniture. Benches should be of a design and material to mitigate the need for maintenance, for example by using recycled plastic benches similar to those already in place on the site.

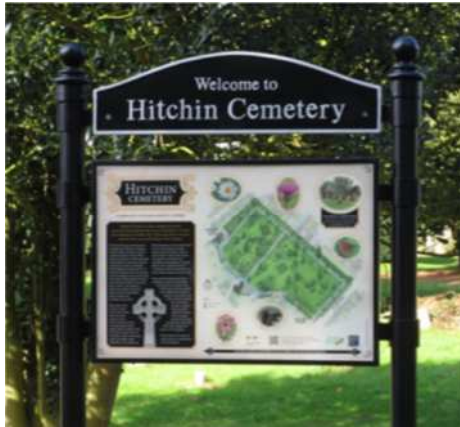
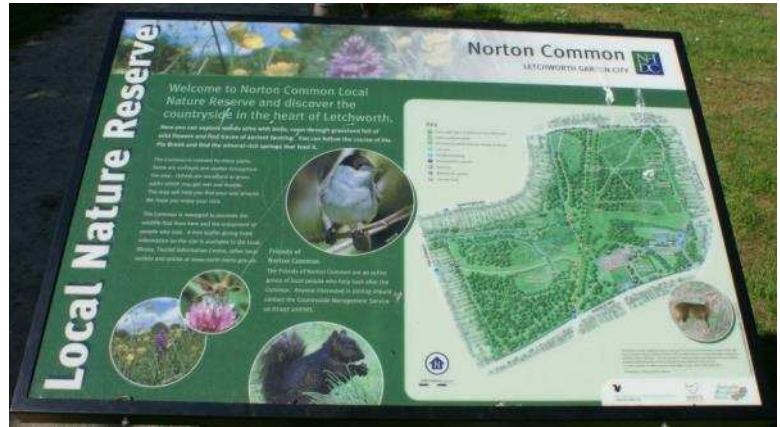
Examples of interpretation at other NHDC sites (Hitchin Cemetery and Norton Common)

There is currently no means of advertising Butts Close on the site, whether in terms of its historical interest or its current attractions. Designing and installing interpretation panels at the main entrances from Fishponds Road and Bedford Road which give visitors information about the long history of Butts Close should help encourage local enthusiasm for the site.

An additional interpretation panel next to the pond would provide an opportunity to educate visitors about the biodiversity benefits of ponds, and have a safety benefit by signposting the location of the pond. The Friends of Butts Close should be engaged in the process of designing these interpretation panels, as they will be able to offer valuable local and historical knowledge.

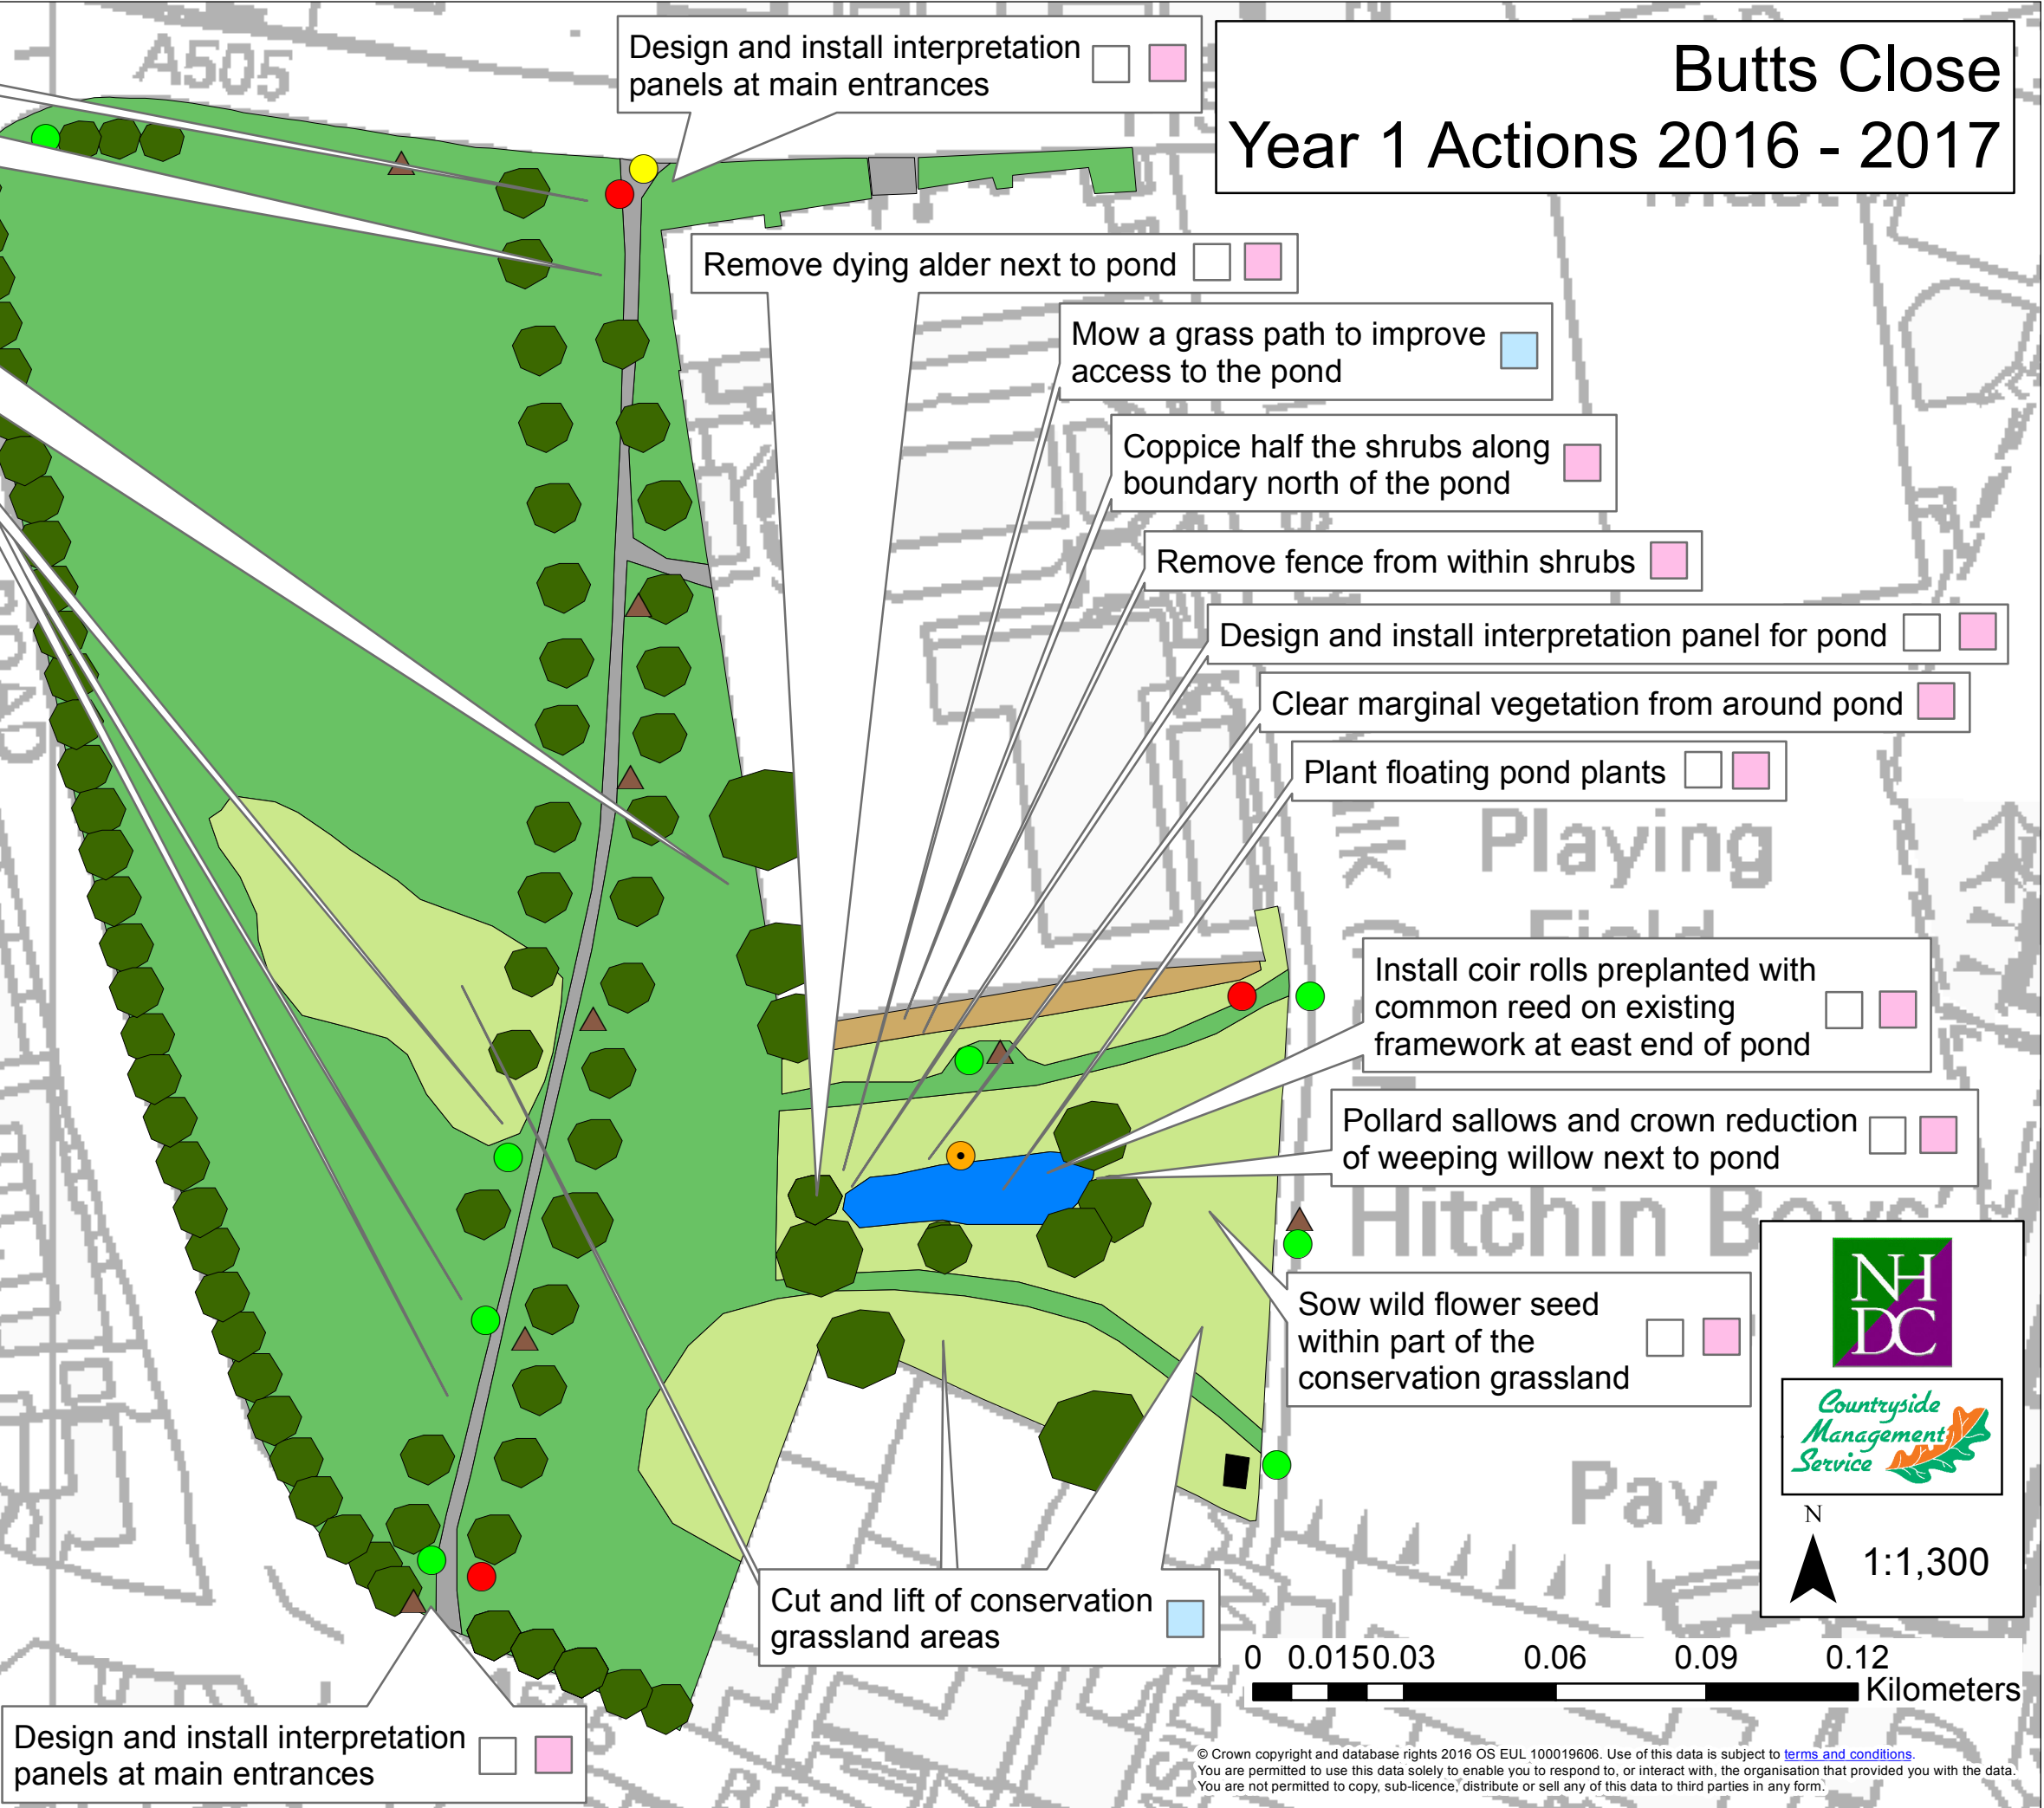
- Plant trees to fill gaps along the central avenue
- Design and cost works to desilt the pond, and seek funding to implement
- Replace all litter bins with lidded version and rationalise bin locations
- Replace all benches

- ▲ Bench
- Buoy
- Dog bin
- Litter bin
- Vehicle access
- Trees
- Amenity cut grassland
- Scrub
- Conservation cut grassland
- Hard surface
- Pond
- Building

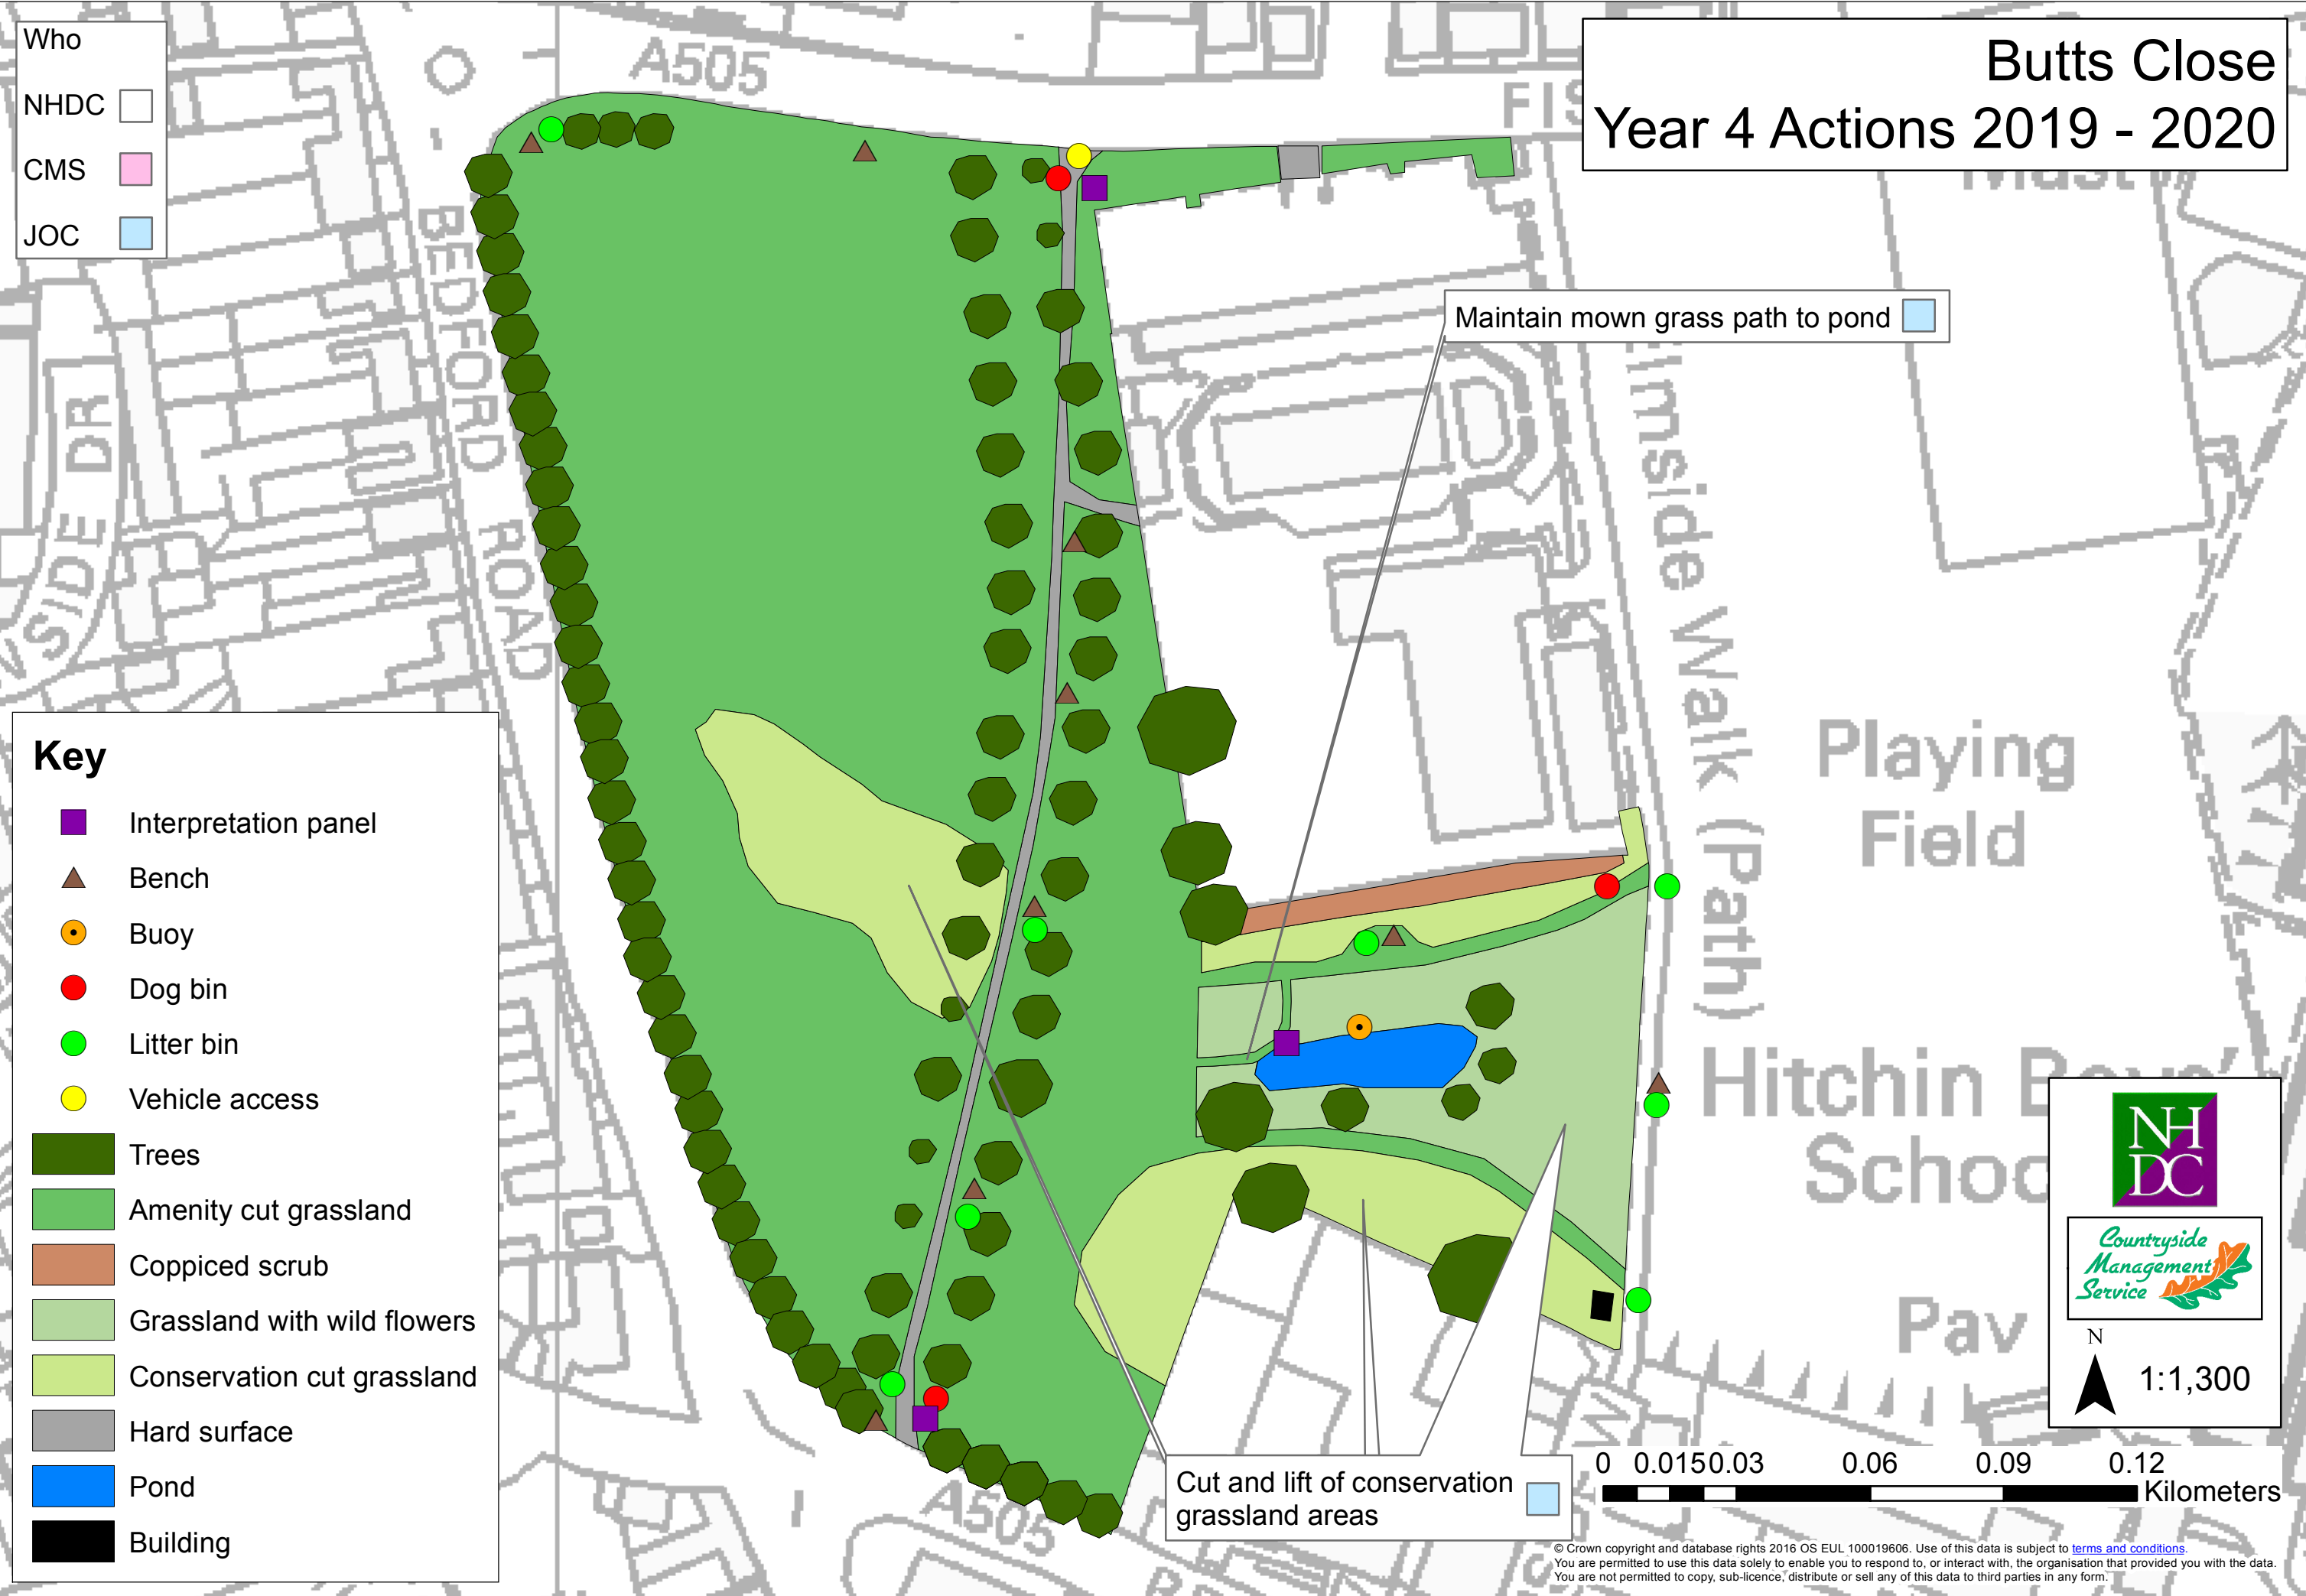
- Interpretation panel
- Bench
- Buoy
- Dog bin
- Litter bin
- Vehicle access
- Trees
- Amenity cut grassland
- Coppiced scrub
- Grassland with wild flowers
- Conservation cut grassland
- Hard surface
- Pond
- Building

Maintain mown grass path to pond

Cut and lift of conservation grassland areas
